Appendix F – Phase I Site Assessment

"PHASE I"
PRELIMINARY ENVIRONMENTAL SITE ASSESSMENT
MC CARTHY RANCH RETAIL CENTER
APN 022-53-002,003,006,007
11, 63, 125 AND 179 RANCH DRIVE
MILPITAS, CALIFORNIA 95035

E-02-09-835

January 11, 2012

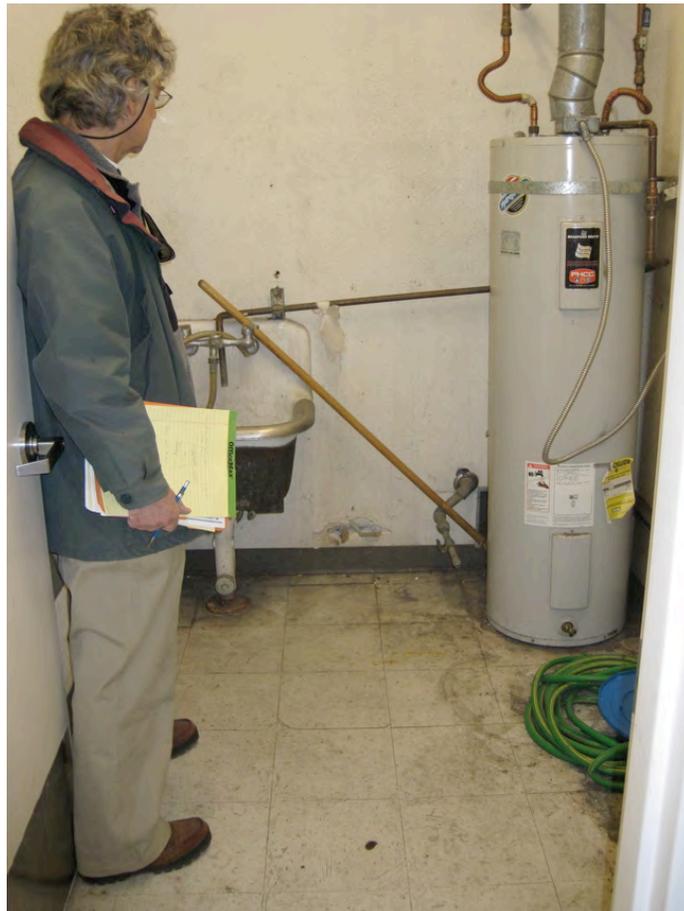
Photograph E: Typical janitor's closet.

Small quantities of janitorial and maintenance supplies were observed in most of the occupied units. The observed volumes and absence of release based on visual observation indicate that these supplies are not likely to be of environmental concern.

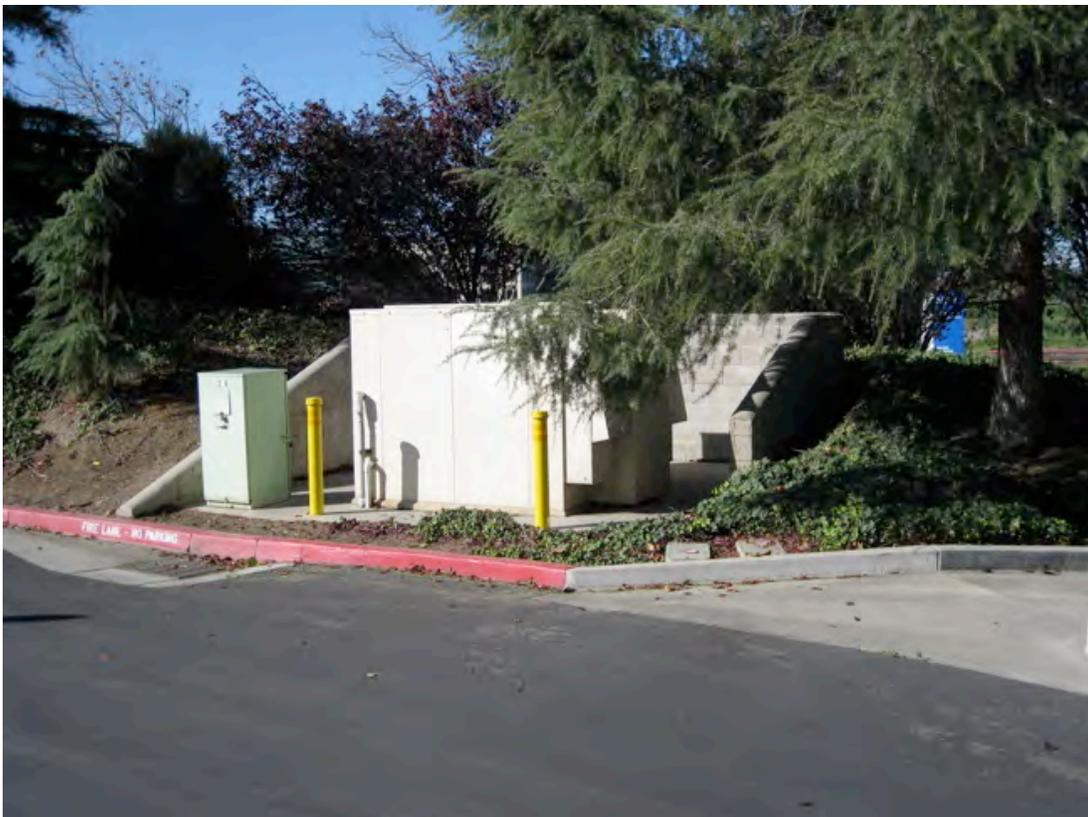
Photograph J: Typical PG&E transformer installation.

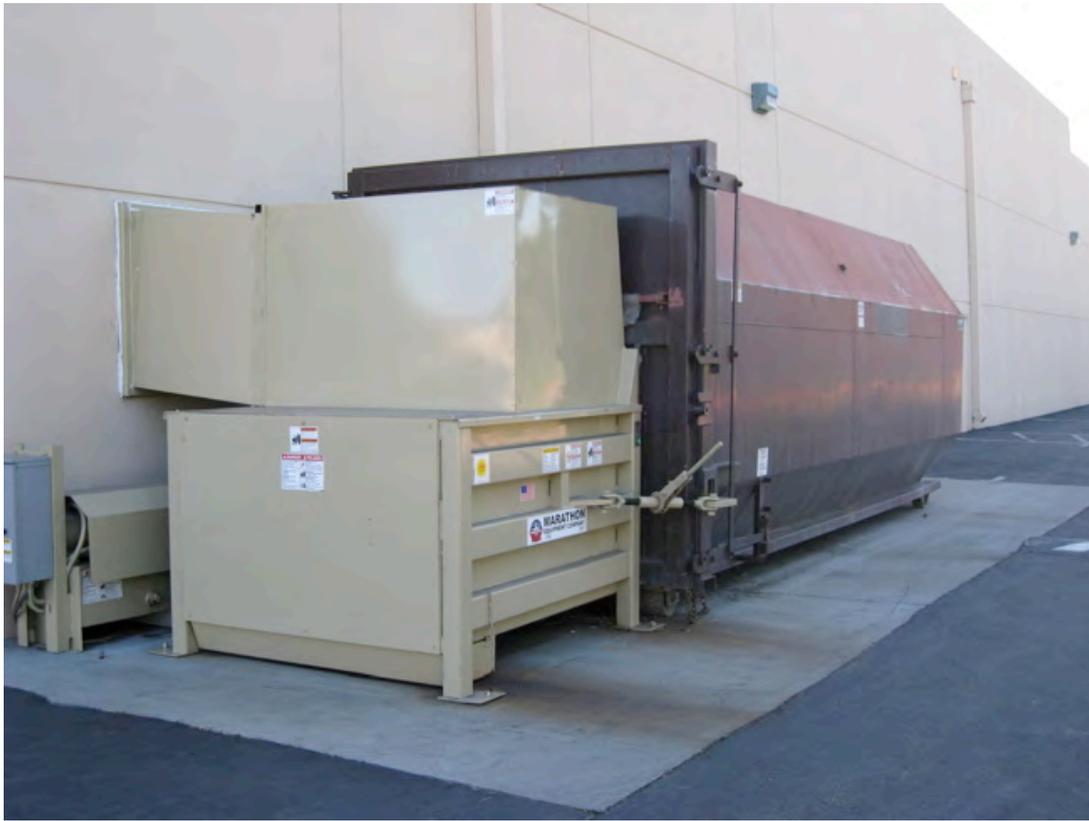
Photograph K: Typical Trash Compactor.

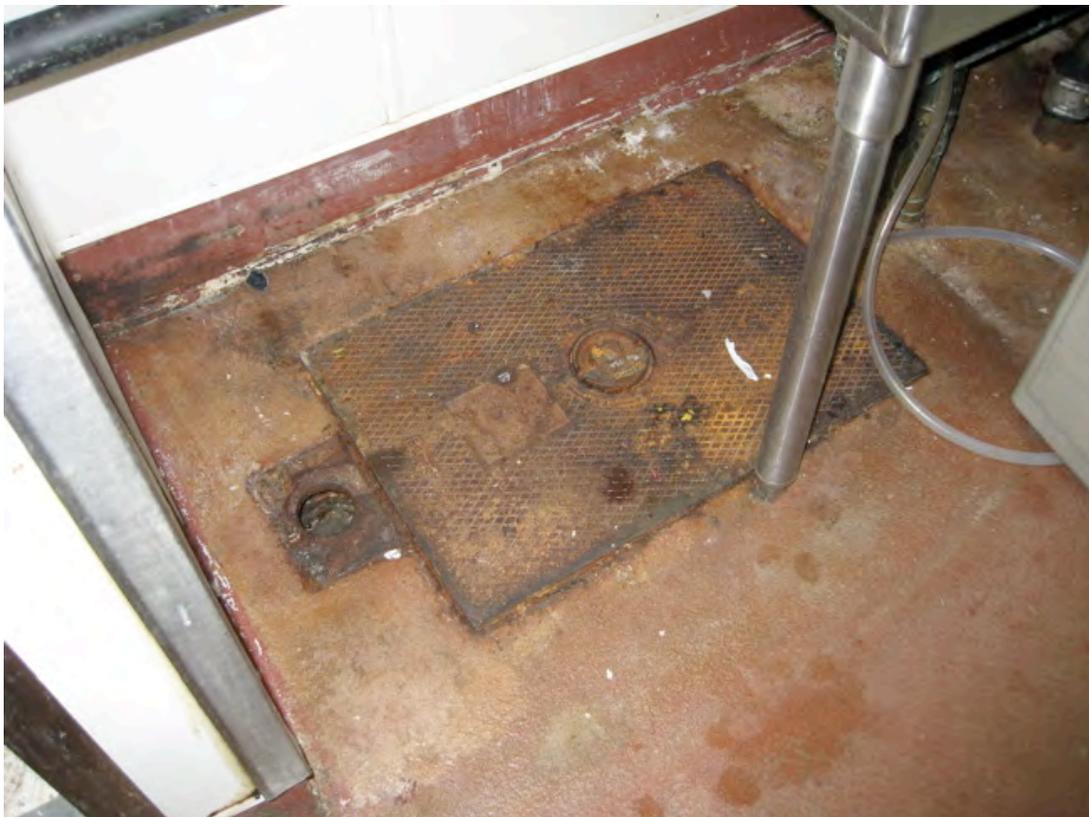
Photograph N: Typical building interior restaurant grease trap.

There were no indications of underground storage tanks or additional vaults or of hazardous material storage within the site. We observed grease traps both within and outside of the various food establishments, all on the east side of the property. Operating personnel indicated that the traps were cleaned by servicing companies on a regular schedule. The grease traps contain oils of vegetal or animal origin, and not of petroleum origin, and thus any possible releases would not be considered a soil or ground water hazard.

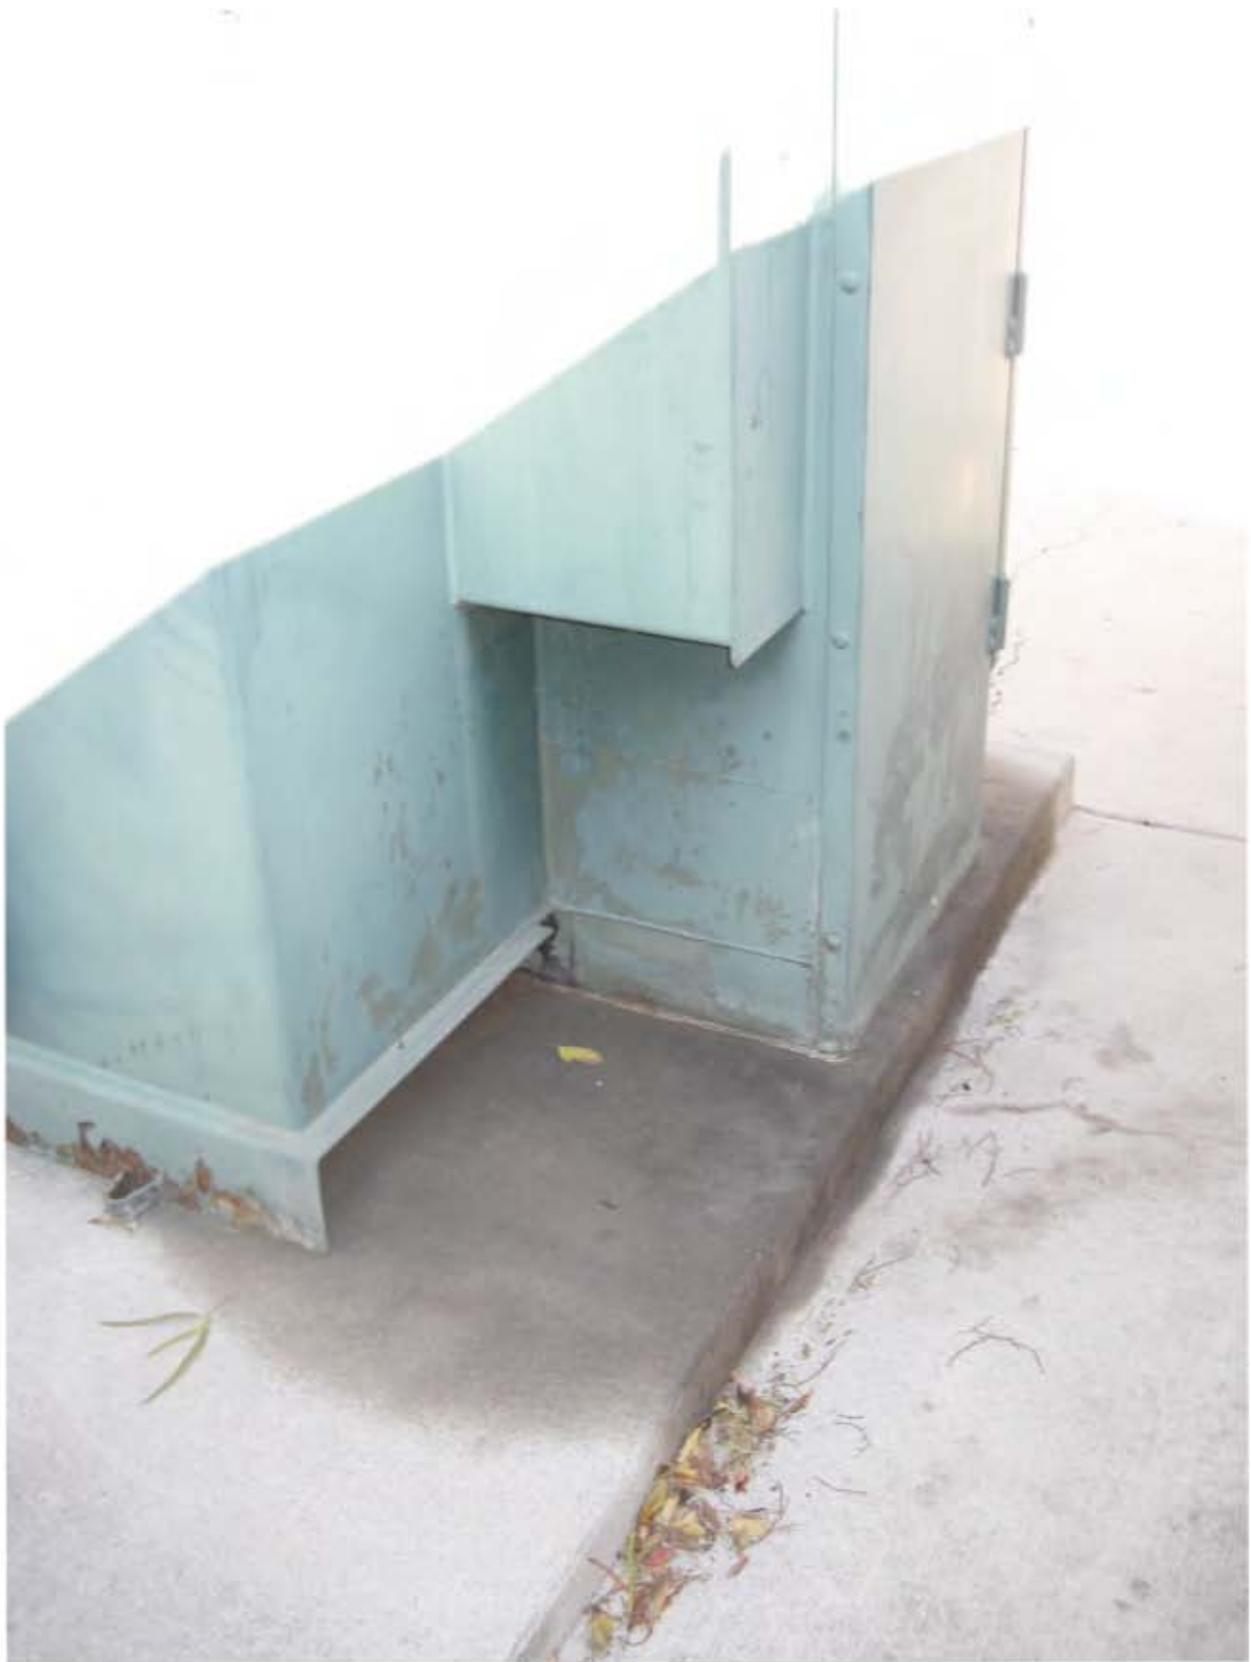
Photograph O: PG&E transformer, showing oil leak stain.

We walked around the building exteriors and parking lot. The asphalt is in generally good condition, and there are no indications of spills or hazardous materials, with the exception of oil staining on the concrete pad supporting a Pacific Gas & Electric Company transformer (T-3064) located adjacent to the parking lot northeast of Unit 181 (Pasta Pomodoro). The stain was noted by URS (2006), and does not appear to be fresh, although it was not possible to determine whether any leaking had occurred since the 2006 URS report was prepared. Photograph O (this report) shows the stain, which looks essentially unchanged albeit possibly slightly larger than the stain shown in Photo No. 6 of the 2006 URS report. PG&E replaced the fluids in all of its transformers by the early 1990s to remove PCBs from the interior cooling fluids. Thus, it is highly unlikely that this transformer would contain PCBs or other hazardous materials. We noted additional transformers, refuse disposal bins, and cardboard compactors, but there were no indication of fluid leakage or release.

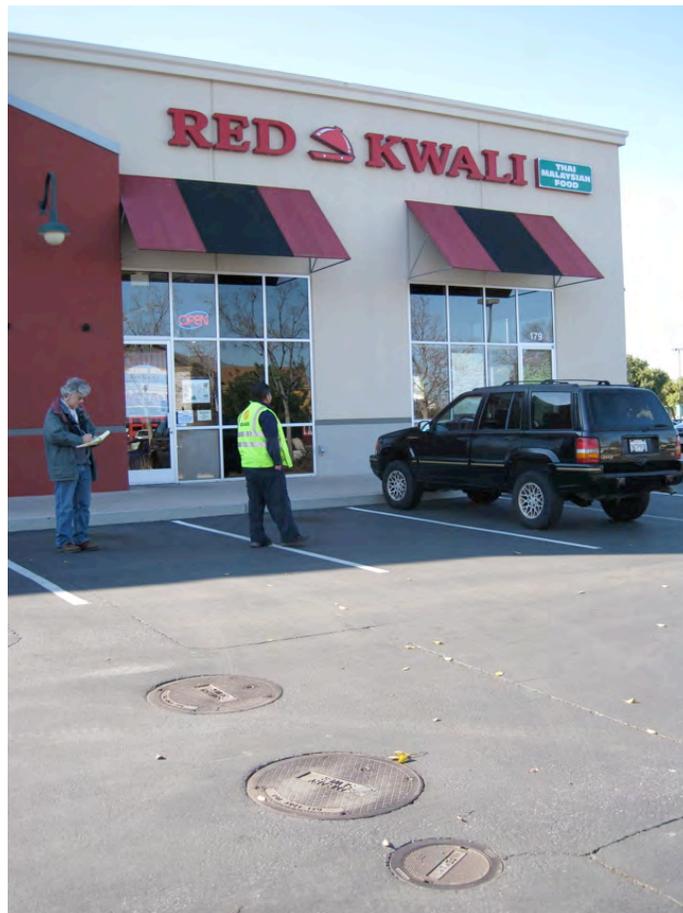
Photograph Q: Restaurant exterior grease trap.

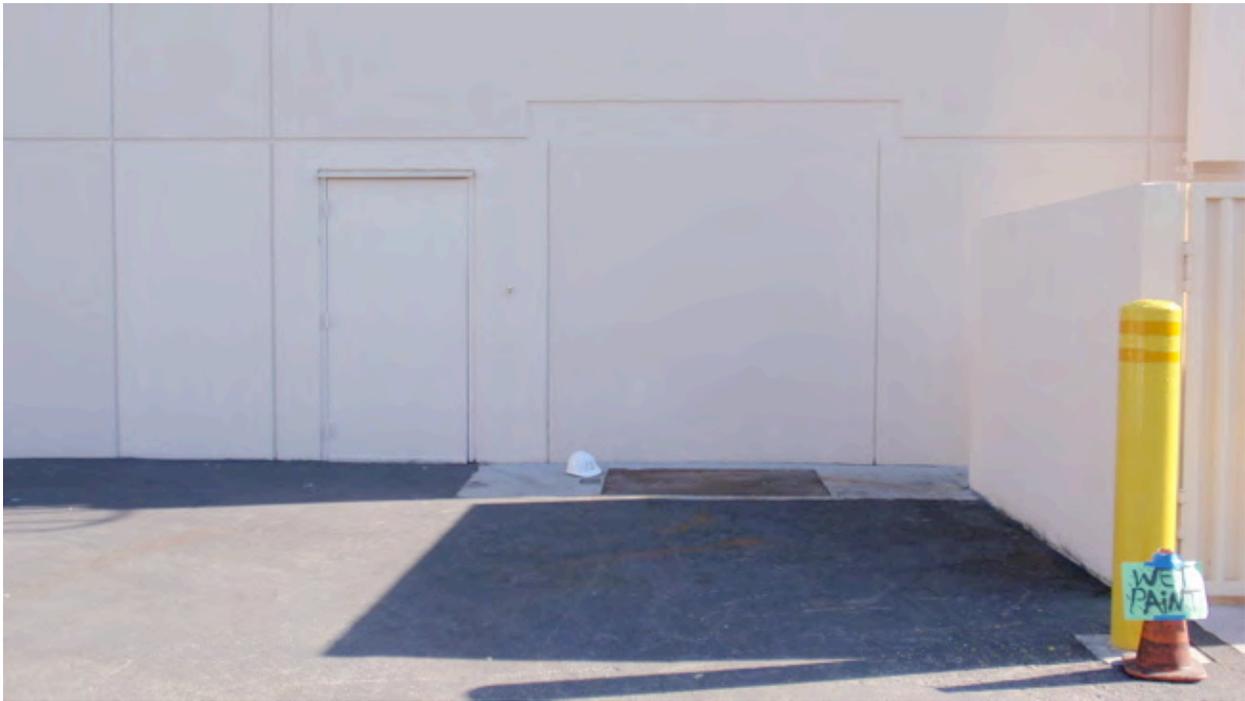
Photograph R: "Vault" adjacent to NW wall of 217 Ranch Drive (David's Bridal).

We identified an apparent underground “vault” adjacent to the northwest facing exterior wall of Unit 217, David’s Bridal (Photographs R through W). We observed a rectangular steel plate/cover placed flush with a concrete surface in the parking lot, which appeared to post – date construction of the adjacent building and parking lot. Two round covers on the order of 3 inches diameter were located within the steel plate. There was an additional plugged opening immediately adjacent on one side, and two additional covered openings at greater distance from the plate at each end. We were not able to access either the two covers within the plate or the single plugged location to the side, nor were we able to remove the steel plate/cover; we were able to remove the two more distant covers, exposing pipes which

We did not observe any similar features on the property. Based on its being surrounded by concrete within the asphalt surface, and on "cuts" into the asphalt (for removal) at the corners of the concrete, it appears that the "vault" was installed after the center was constructed (post 1995). Based on its appearance (restraining screws were rusted into place) and on business directory listings and interviews with the tenant (David's Bridal), it has not been in use since at least 2006 (McCarthy Ranch was constructed in 1995).

A vault of unknown origin is present adjacent to the rear outside wall of David’s Bridal, 217 Ranch Drive. The vault was covered and inaccessible at the time that it was first observed during our site reconnaissance; it is described in Section 6.2.2. A previous tenant at this location is listed in the EDR (2011f) 1996 business directory summary as "E7 Discovery Zone Inc". An Internet search for this company was not successful. However, a search of Wikipedia indicates that “Discovery Zone” was a chain of children’s entertainment facilities founded in 1990, which went bankrupt in 1996, and that “E7” is in all likelihood “DZ”. The chain was subsequently purchased by Chuck E. Cheese’s, which converted some locations and closed others (there are no indications that the subject site was converted to a Chuck E. Cheese’s location). An additional search of business and telephone directories at the San Jose, California Library California History Room indicates that Discovery Zone is listed from 1995, when the McCarthy Ranch development was constructed, through 2000. In 2001, it is replaced by David’s Bridal, which has occupied the site from that date to the present. A facility such as “Discovery Zone” would most likely include food preparation and sales.

- An underground “vault” is present behind David’s Bridal, 217 Ranch Drive. Based on our observations and the identification by a specialty contractor, this feature appears to be a grease trap, most probably associated with a former tenant, Discovery Zone, a children’s amusement center. Based on the use of the adjacent building as a children’s’ amusement center and subsequently as a retail bridal shop, use of the vault for other purposes is remote. In our opinion, it is thus unlikely that this feature would have stored or released hazardous materials to the adjacent soil and ground water. The historical use of this feature is therefore a de minimis condition. Further evaluation or action is not recommended.

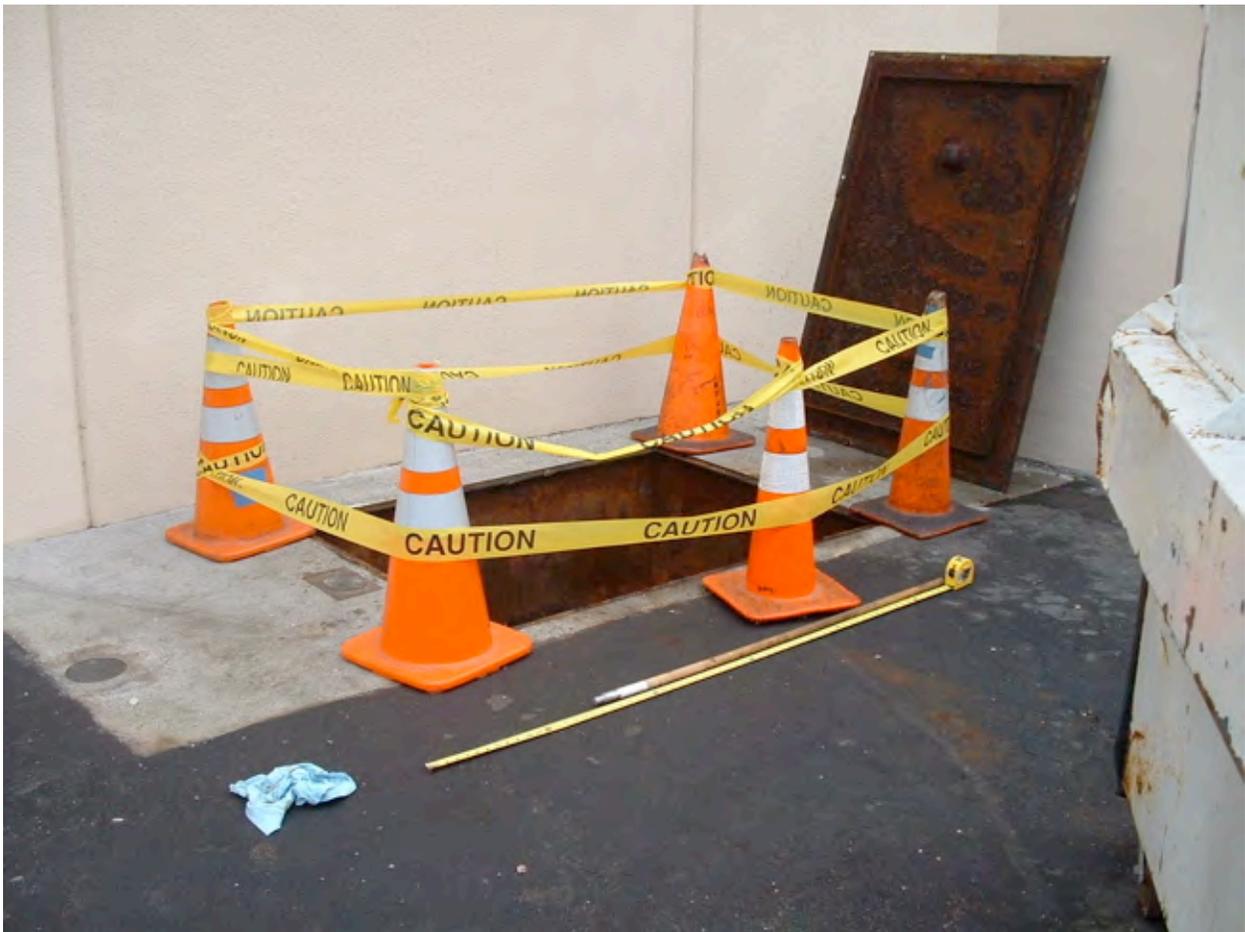
Photograph S: 217 Ranch Drive "vault", top removed.

The vault appears to be steel, heavily corroded. At the ground surface the vault is surrounded by concrete. We could not determine if the entire vault is encased in a concrete box, which would be expected as a typical and standard practice to prevent crushing and to protect the vault. Assuming the presence of a concrete encasement, we do not know its quality or condition (it could be cracked). There appear to be two corroded plugged (?) openings within the vault interior. Vertical metal plates ("baffles"?) were located at the southern end.

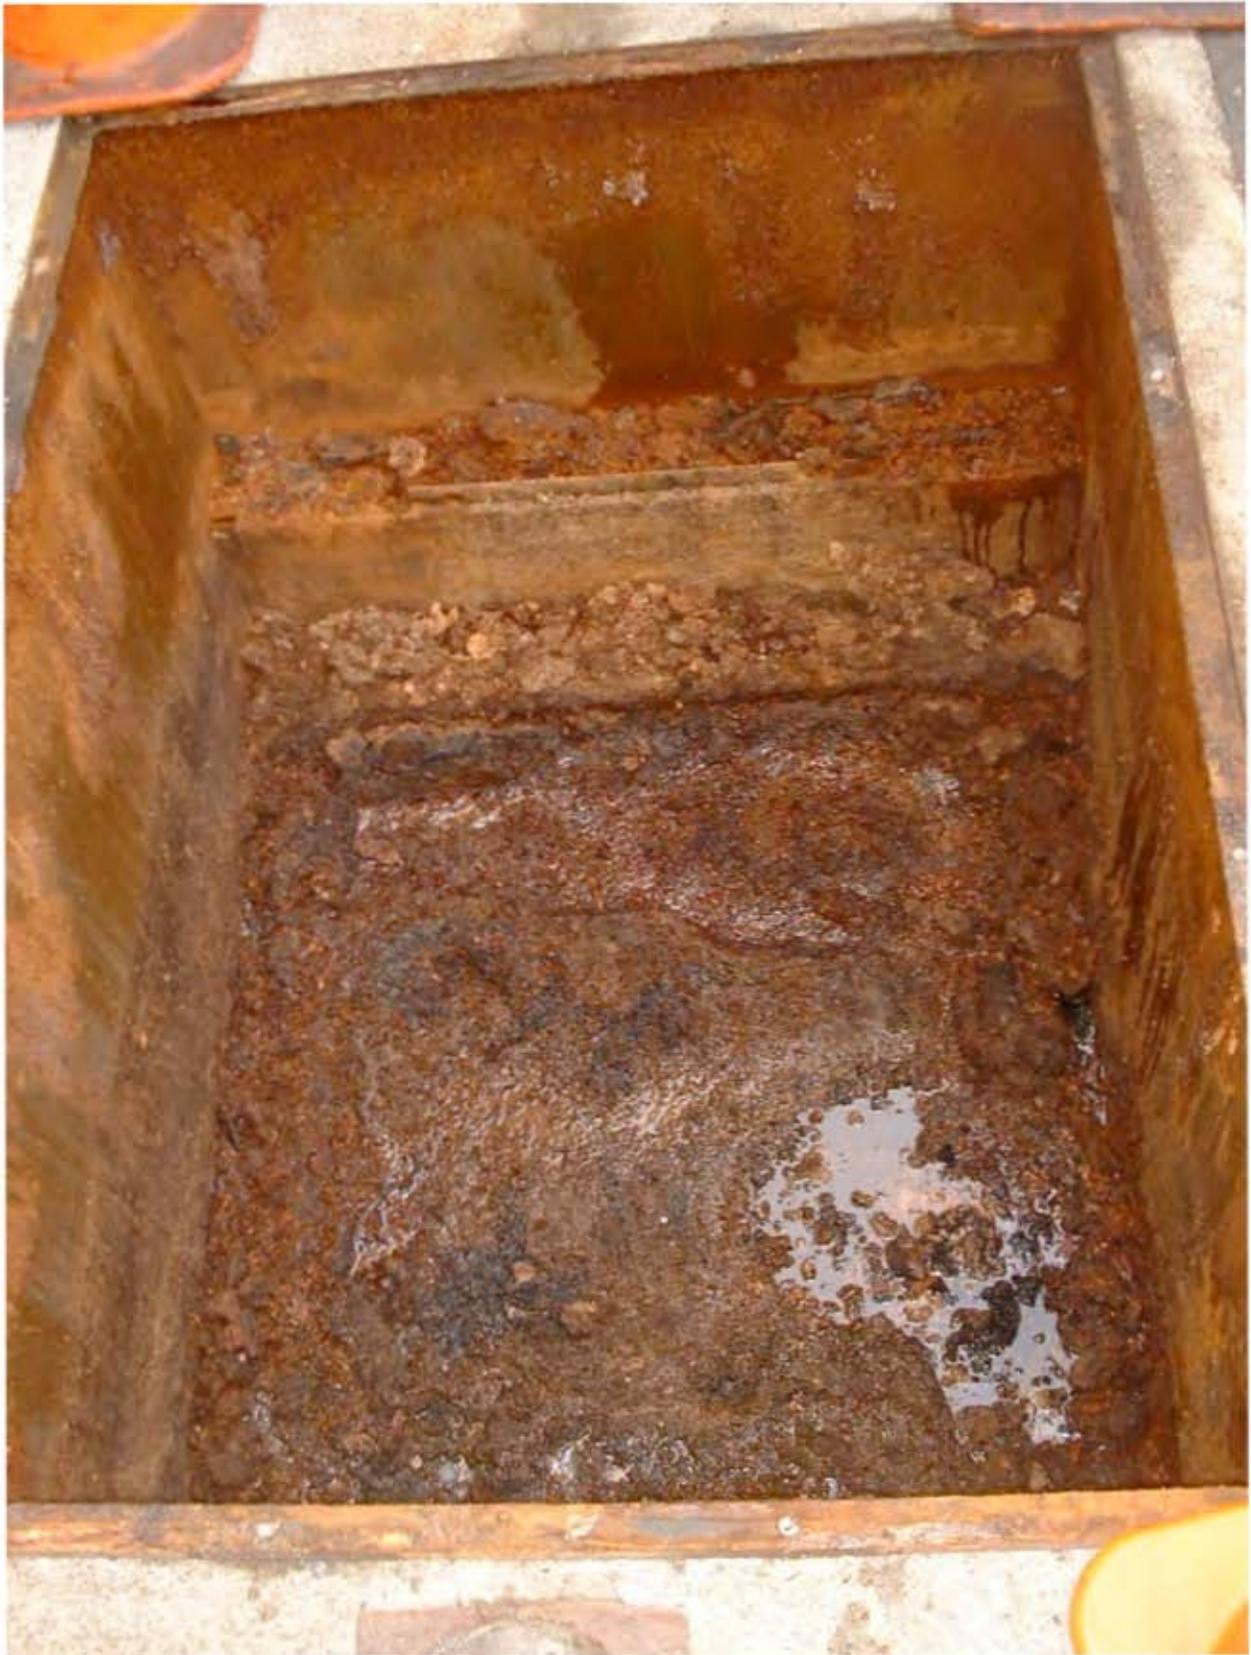
Photograph T: 217 Ranch Drive "vault" contents view south (fluid level approximately half of vault depth).

At the User's request, we obtained a grab sample of the water contained by the "vault". The vault was not sealed at the ground surface, and we infer that the contents present at that time consisted of surface precipitation infiltration at the perimeters of the "vault" cover and through the two round covers of openings within the plate (as noted above, a slight oily sheen was present on the fluid surface). The analytical lab report is included in Appendix F of this report. The following compounds were detected:

As discussed in Section 6.2.2, a grab fluid sample of the “vault” contents was obtained. Low levels of petroleum hydrocarbons, VOCs and metals were detected. The water appears most likely to have infiltrated the “vault” from surface leakage originating from precipitation runoff. It is unlikely that the fluid, with its low contaminant concentrations, represents or relates to the prior use of the “vault”, which has been identified as a grease trap. The vault was approximately half full of fluid when observed. The analytical results are deemed inconclusive, but consistent with water infiltration and runoff from the ground surface as the vault is adjacent to the parking lot.

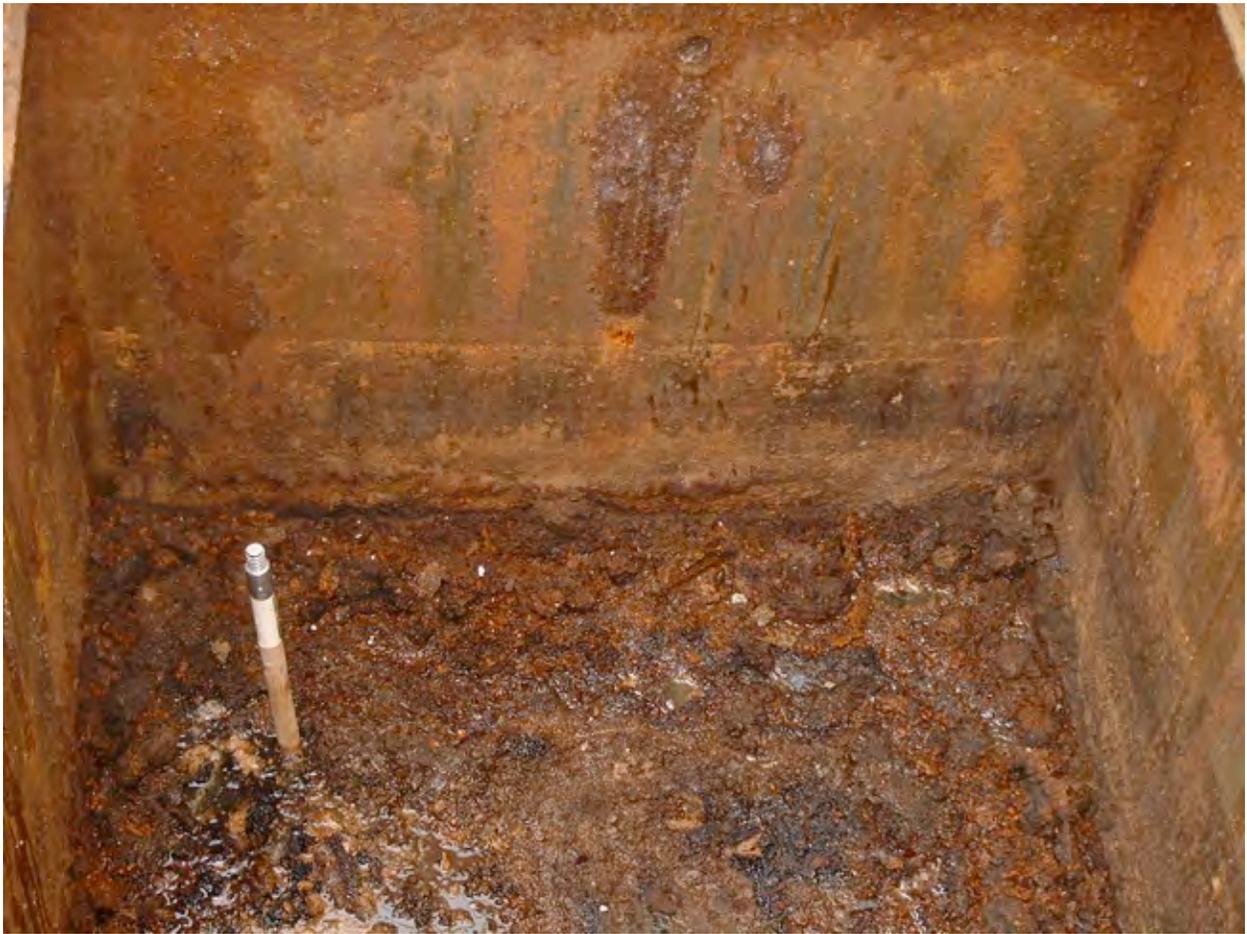
Photograph U: Additional “vault” interior, view north (PVC pipe not part of “vault”).

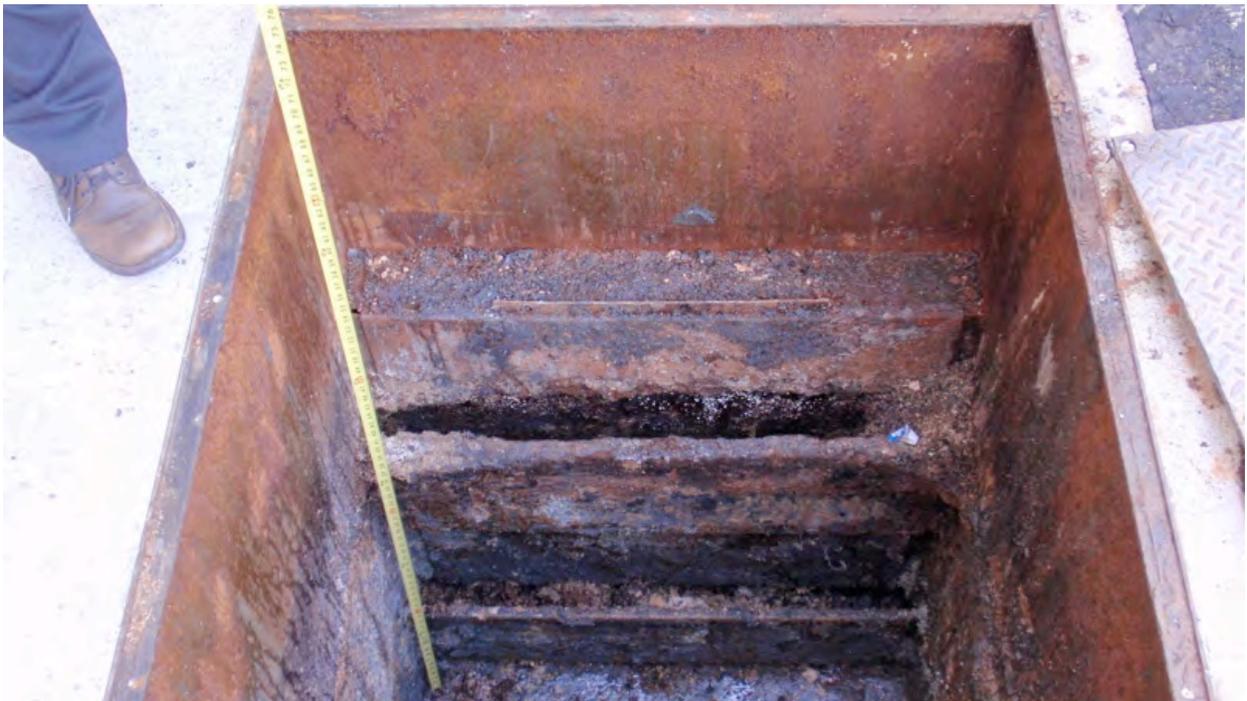
Photograph V: “Vault” following removal of fluid, view south.

We viewed the “vault” with an environmental contractor, represented by Chris Pacis of Decon Environmental Services. Mr. Pacis did not believe the “vault” was intended for hazardous materials storage, but he was not certain of the purpose of the installation. We then viewed the “vault” with a contractor which services grease traps used by restaurants and commercial kitchens, ARS Rescue Rooter, represented by Tom Schiess. Mr. Schiess identified the “vault” as a commercial grease trap, although of unusual design (generally, baffles are located near the middle of the trap, as opposed to this feature, with baffles at one end). He thought the trap had at one time been utilized as intended, based on his observation of remnant grease at the southern (baffle) end.

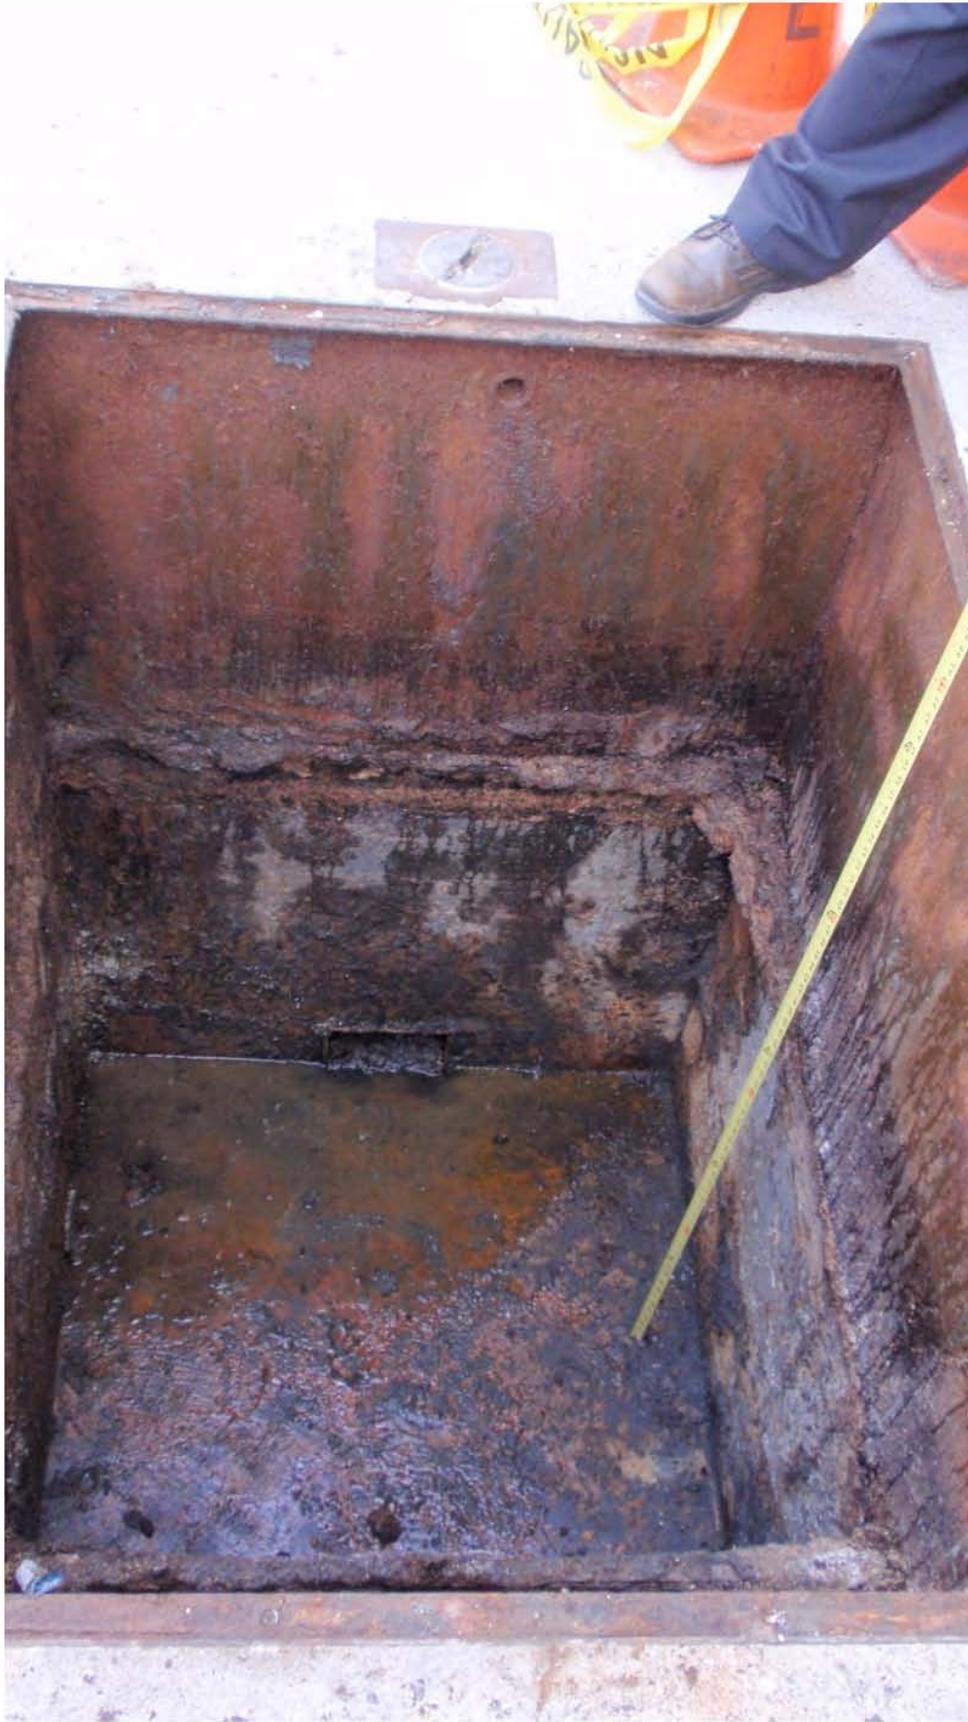
Photograph W: "Vault", fluid removed, view north.

The "vault" located behind David's Bridal, 217 Ranch Drive, has been identified as a grease trap. Although we have not been able to definitively confirm its installation and use history, it is unlikely that this feature was used for hazardous materials storage or disposal, and thus it is not considered as a data gap.
